**LTPP Seasonal Monitoring
Program**
Site Monitoring Suspension
Status Report
Section 871622
Bracebridge, Ontario

SEASONAL MONITORING PROGRAM SUSPENSION STATUS REPORT

ONTARIO SECTION 871622

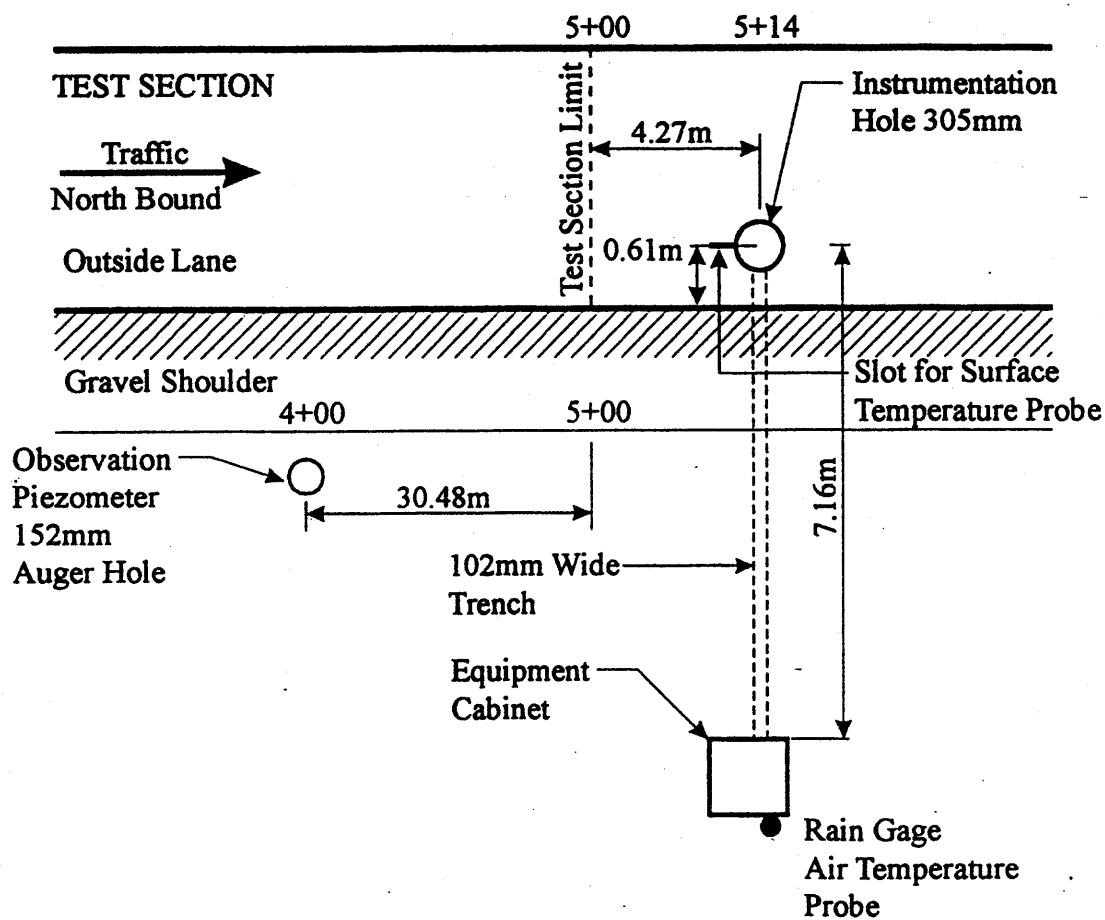
Figure 1. Location for Seasonal Monitoring Instrumentation Installed at GPS 871622

Figure 1 shows the locations of the installed instrumentation at the site. The instrumentation hole is at Station 5+14 and the piezometer is at Station 4+00. Table 2 gives the elevations of the portion of test section 871622 that was used for elevation measurements. All offsets are from the PK nails found at the outside pavement edge.

- Height of Air Temperature Probe (center): 3.40m
- Height of Tipping Bucket Rain Gage (center): 3.40m
- Total Depth of Piezometer: 4.28m
- Distance of Piezometer Below Ground Level: 216mm

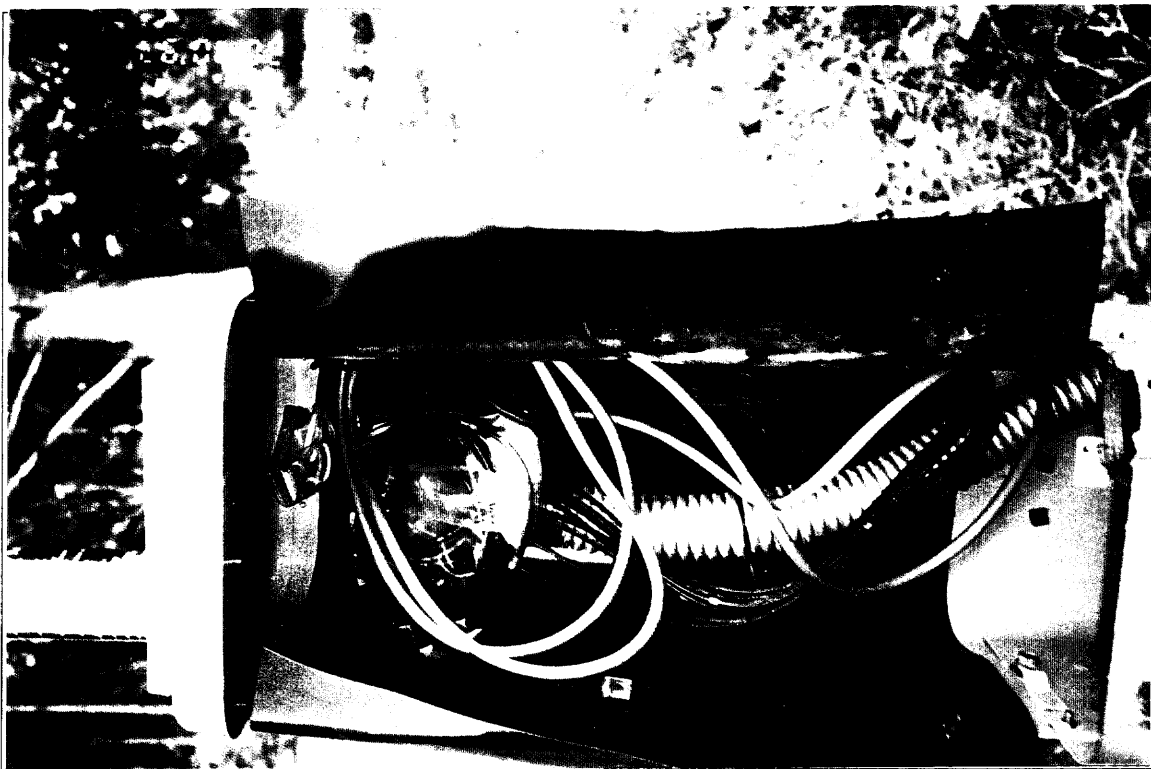
Inside Equipment Cabinet, Seasonal Site 871622 - Oct. 1997, after Suspension Activities
